SUBJECT: C14H-05-0007 – Brown's Flower Shop. Conduct a public hearing and approve an ordinance amending Chapter 25-2 of the Austin City Code by rezoning property locally known as 4301 Avenue A from family residence, neighborhood conservation (SF-3-NCCD) combining district to family residence-historic-neighborhood conservation (SF-3-H-NCCD) combining district zoning. Historic Landmark Commission Recommendation: To grant family residence-historic-neighborhood conservation (SF-3-H-NCCD) combining district zoning. Planning Commission Recommendation: To deny family residence-historic-neighborhood conservation (SF-3-H-NCCD) combining district zoning. Applicant: Historic Landmark Commission. Owners: Mike and Jeanette Freitag. Agent: Dallas Grant. City Staff: Steve Sadowsky, Historic Preservation Office, Neighborhood Planning and Zoning Department, 974-6454.

CASE NUMBER: C14H-05-0007

HISTORIC NAME: Brown's Flower Shop

Re: Engineer's Visual Structural Inspection of Structures - 4301 Avenue A / Austin, Texas

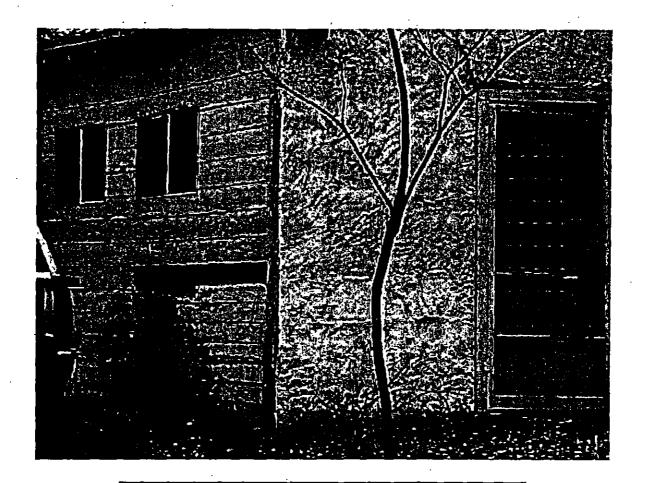
View showing deterioration of siding on north side of building and stucco on west side.

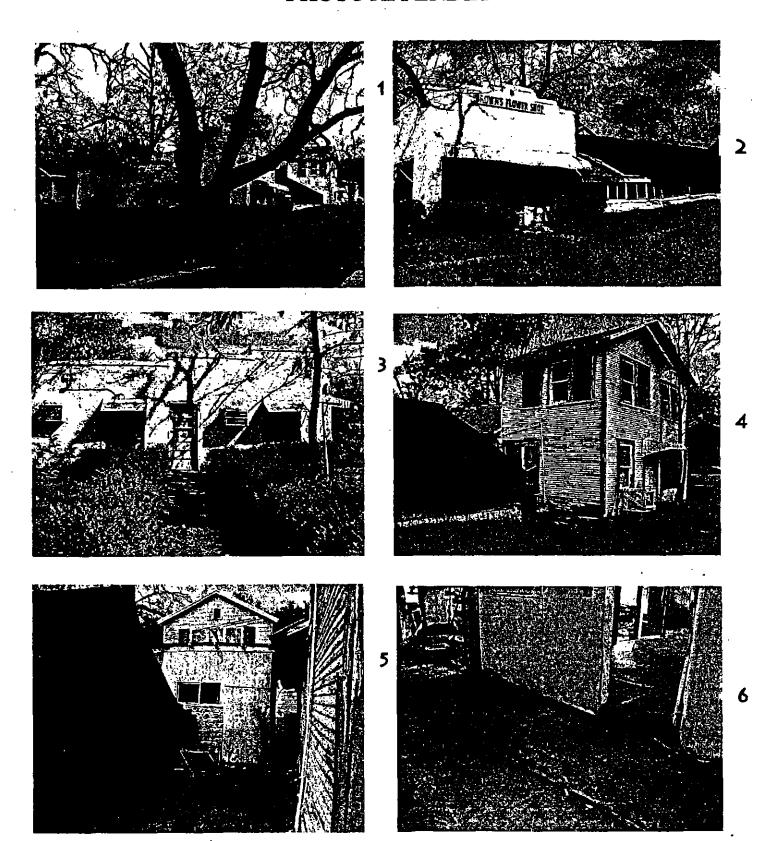
PHOTO APPENDIX

In the interest of best portraying physical conditions and limiting the use of mere words to describe my observations I have incorporated photographs taken 3/24/05 and shown in the Photo Appendix herein. These photos show the westerly (corner) 1-story building (operated as Brown's Flower Shop) in Photos 1-3. The easterly 2-story dwelling is pictured in Photo 4 (along with the east end of the plant greenhouse attached to the flower shop building). Photo 5 shows a view along the driveway between the greenhouse and dwelling, of a poorly constructed and dilapidated garage/storeroom building.

In engineering and construction circles, buildings generally are evaluated as serviceable and/or economically repairable based on the structural acceptability or repairability of the In the case of the 1-story stucco "shop" building, the foundation is a concrete slab-on-ground (of poor concrete finish and at various different finished floor elevations). Although I did not invade the building interior walls to confirm, I believe that the building originally was constructed as a pier-supported structure with interior pier/beam wood floors, and at some time—when interior floor structure had deteriorated—then the floor debris was removed and replaced with the present nonreinforced concrete which was generally spread (in different "pours" within the various rooms. Conditions of 3 separate floor heights are shown in Photo 6, and a major crack and separation in the main (larger) floor concrete is shown in Photo 7. This "floorslab", according to my interpretation of its genesis, is not supporting the building in any sort of stable or dependable manner but rather original cedar post provide pier support, and the slab simply is "in-place. The floorslab being unreinforced, is too fragile to be piersupported (for stability or leveling) on retrofitted foundation piers; it is substandard, not repairable, and has failed.

The "greenhouse" building is a lightweight 2x4 roof structure, supported on low perimeter walls and a series of 2" and 3" steel pipe columns set in concrete footings. Photo 8 shows patches-on-patches of a joint in the front face of the shop wall where the greenhouse joins onto the stucco shop building; the meandering vertical separation gap testifies to the fact that there is (and had been) relative movement between the 2 structures. Photos 9 and 10 show the rusted and disintegrated status of the larger (3") and better-footed interior support pipe columns which hold up and stabilize the greenhouse. Other components of the roof structure are constructed in a way that never conformed with any building code and are not repairable to meet code, but could be totally demolished and re-built. There is no structural elevation above exterior yard grade (as shown in Photo 11), such that exterior storm water easily can flow into the lower elevation rear floor of the "shop" and into the greenhouse. Perhaps that is not to be condemned for a greenhouse but repeated moistening of wood-frame support walls both in the shop and greenhouse leads to deteriorated wood and conditions conducive to mold and termites.

The 2-story dwelling also is a pier-beam supported structure; over the years it has "settled" on its cedar post pier foundation so as to be lower by approximately 5 inches than a previously-built concrete Front Entry Stoop. The typical horizontal floor sill beams (supported by piers) have deteriorated (because of close proximity to soils and moisture from roof storm water run-off-and-back-splatter). Photo 12 shows totally deteriorated wood at the House left front (southwest) corner, where the wood siding is totally rotted away to expose the location of a wood 4x6 sill beam which also has rotted away. Consequently this house foundation has settled non-uniformly and there is a 7" elevation (levelness/flatness) variation within this 4 --room lower floor residence.

Access to the 2⁻¹ level apartment is via a poorly-attached steel stairway that was home-built of inadequate steel (built for different, less steep application) and "kluge-ed" onto the alley-exposure of this building. These conditions show in Photos 13 (the stairway)

and 14 (non-safe handrail of stairway and missing/dangerous guardrail of porch). On the rear (north) of the 2-story building is/was a "lean-to" shed of corrugated sheet metal roofing, supported on whitewashed posts (which also supported a privacy fence). All these have collapsed as seen in Photo 15.

Within the 2-story dwelling are numerous evidences of long-term roof leaks (Photos 16, 19, 21 and 22). Interior unsafe conditions include (one of several) exposed, loose-wire electric extension receptacles (Photo 23) and a section of totally-rotted ceiling structure, which also is the floor for the 2nd level Apartment above (Photo 24).

The "garage/storage" building built against the north property line, leans over the line and is off-vertical by 9" in 7 ½ ft.... and walls are non-salvageable in my opinion; these conditions are shown in Photos 17 and 18.
